## Primary Containment – Capron Manufacturing

**Customer:** Capron Manufacturing

**Applicator:** RPS Liners of Illinois

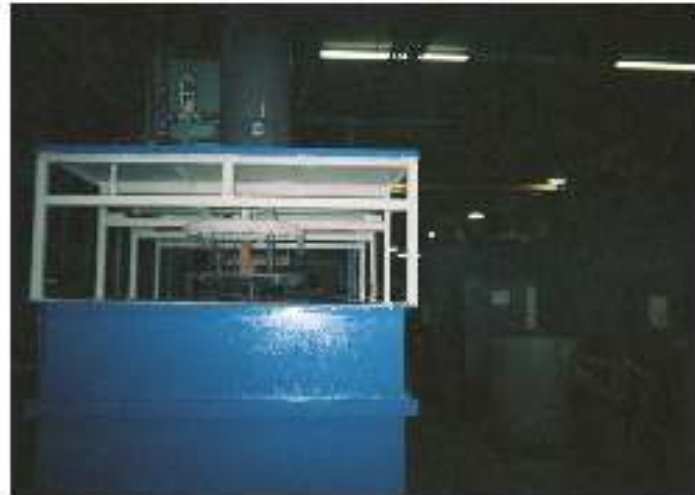
**Problem:** Capron has a primary process tank that contains chromate. Chromate is a very corrosive material and was eating away the core seal liner that initially lined the tank.

**Solution:** Because of the chromates corrosive properties, Rhino Linings' Hi-Chem™ formulation was specked for the job. Hi-Chem was sprayed at 1/2" thick on the floor and 1/4" on the walls of the tank.

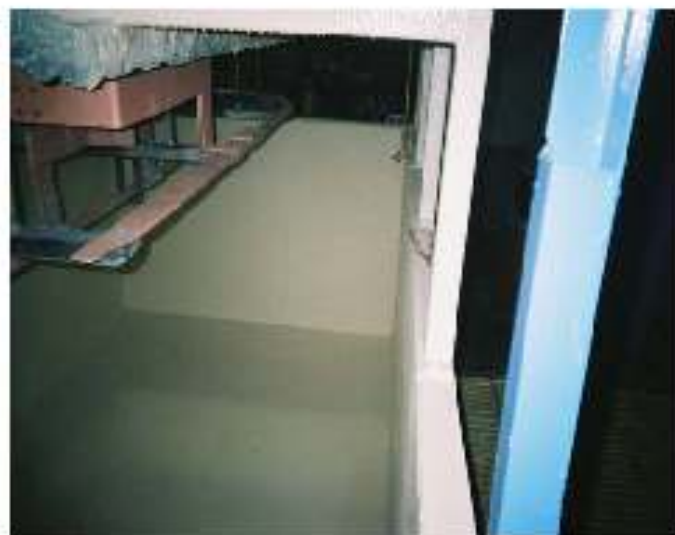
**Results:** Rhino Linings' Hi-Chem formulation has protected this primary storage tank from corrosion and leakage since its application approximately 1.5 years ago. Capron recently emptied out this tank and found that the chromate had absolutely no affect on the Hi-Chem to date. The company also noted that Rhino Linings' polyurethane liners were much easier to clean than the core seal liner they had before.
