## Aggregate – Granite Rock Company

**Customer:** Granite Rock Company

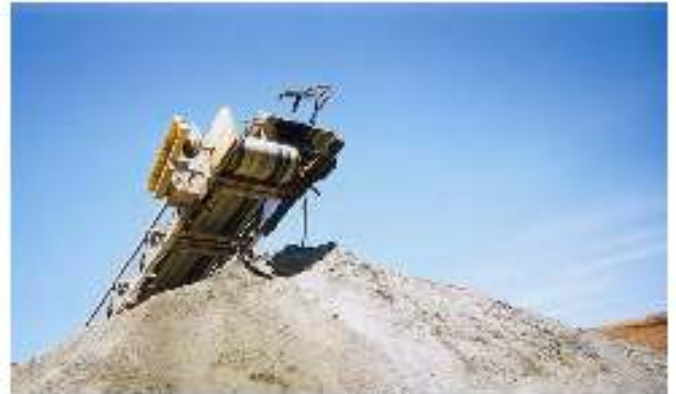
In this particular situation, an aggregate chute was constantly being damaged by impact and abrasion. Several steel plates (approximately 2ft square) with 2" of mechanically attached rubber were fastened to the chute to protect it. This proved to be a short-term solution as these plates only last about three weeks before requiring replacement.

The abrasive movement of the granite wore through the rubber facing to the steel plate and into the steel chute. Repair and replacement of the chute in this type of application is costly in both materials and labor.
