Transportation – A Southern California Transport Co.

Customer: A Southern California Transport Company

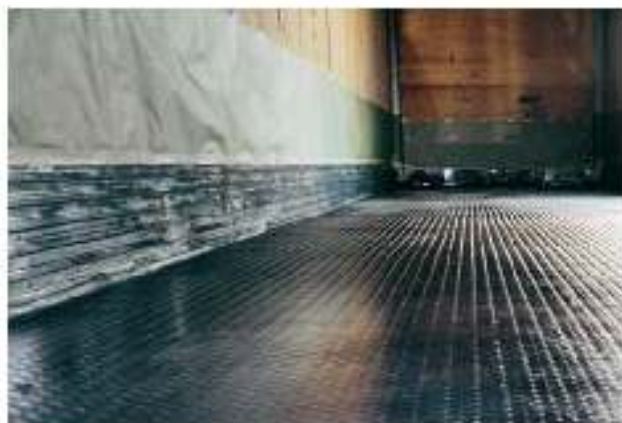
Problem: As environmental agencies became stricter about the transportation of hazardous materials, this transportation company found itself under close scrutiny. During transportation, a lead dust develops that leaks from the trailer, creating an environmental hazard.

Solution: After a thorough analysis, Rhino Linings TUFF STUFF[®] was sprayed on the walls and floor. The steel floor and walls were abraded and primed with Primer 251[™]. Rhino Linings' TUFF STUFF was sprayed on to the floor at a thickness of 3/16" and the wall at a thickness of 1/8" thick. The side door was completely sealed from the inside, leaving only the main rear roll-up door accessible to the outside. When closed, the rear roll-up door forms an airtight seal as it sets directly on top of the TUFF STUFF polyurethane lining.

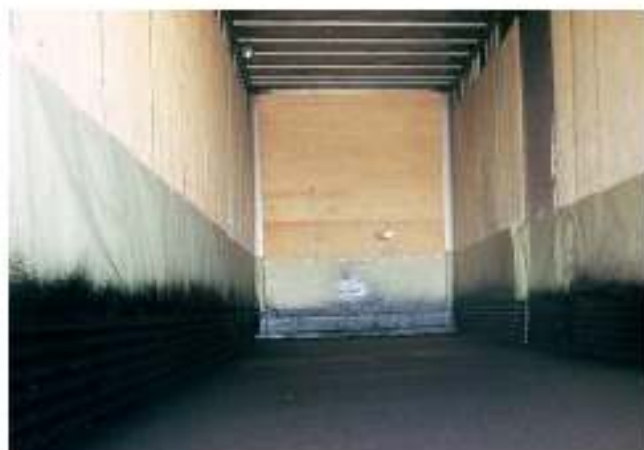
Results: Rhino Linings' TUFF STUFF polyurethane was able to form an airtight and watertight seal to ensure no lead escaped the trailer during transport. Consequently, TUFF STUFF, by nature of its formulation, was able to provide an impact and abrasion resistant lining allowing the trailer to resist much of the damage incurred in the course of transporting materials.
